The Suitability of CRA Lined Pipes for Flowlines Susceptible to Lateral Buckling

SUT Global Pipeline Buckling Symposium, 23-24 February 2011

Duncan Wilmot, Technical Manager, Cladtek International, Australia
Paul Montague, Managing Director, Cladtek International, Australia

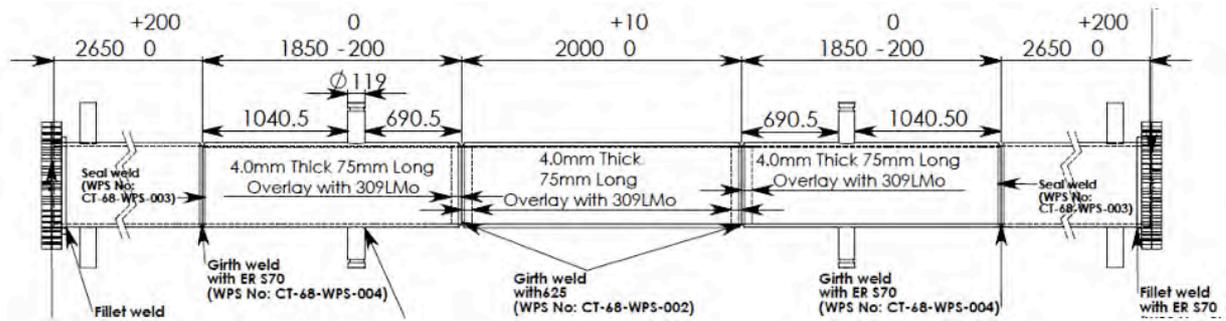
24" LINED PIPE 4 POINT BEND TEST

Base Material: Gr X65 WT 24.3mm
Liner Material: 316L WT 4.0mm

Test Pipe: 01 (With Coating Simulation)

FIGURE 1: Drawing of NPS 24 CRA Lined Test Pipe Configuration

The test pipe assembly (Figure 1) included two pipeline girth welds, 2m apart, in the middle 3.5m pipe section that was subject to constant bending moment. The girth welds were made with Inconel 625 using a qualified GTAW (TIG) butt weld procedure. The CS seam weld in the 2m pipe section between the girth welds was located at the 180° position (bottom), while the CS welds in the adjacent lined pipe sections were offset from this (at 135° and 225°). Alloy steel load pins were welded to the outside of the test pipe along the bend neutral axis.

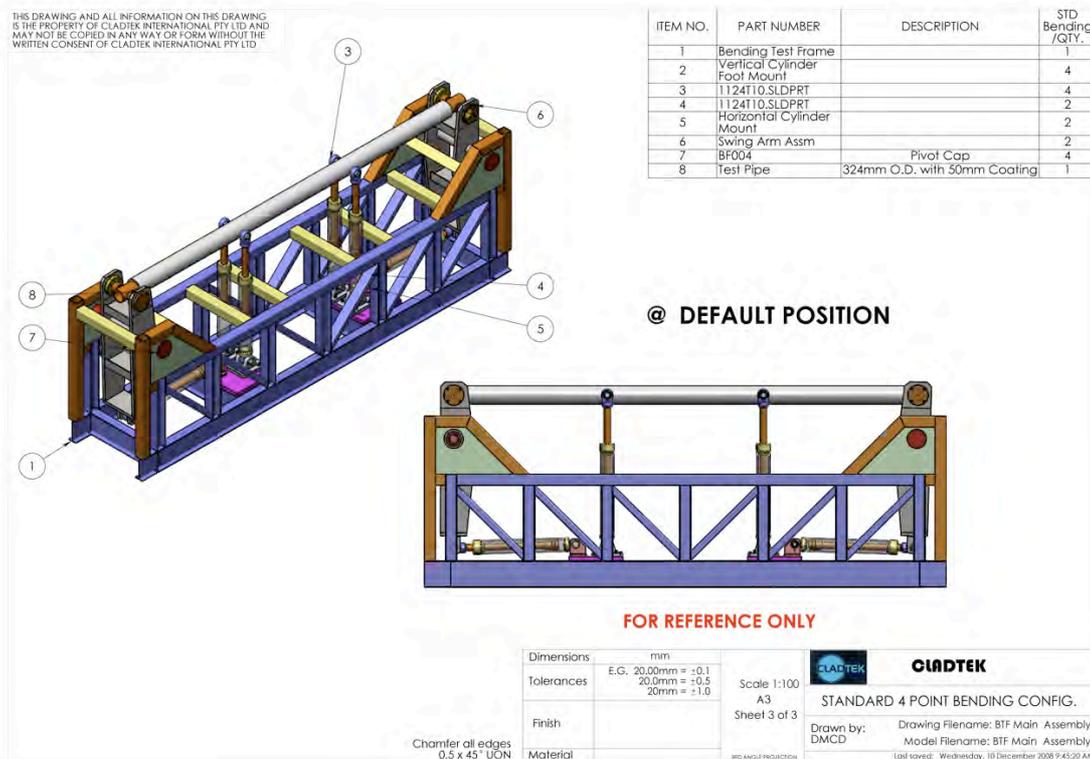
FIGURE 2: Diagram Illustrating Test Rig in 4-Point Bend Test Configuration

Testing was performed at Cladtek’s dedicated test facility in Batam using a 4-point bend test rig, equipped with 4 x 100 tonne two-way vertical hydraulic actuators, able to bend full scale 11-12m long test pipes using programmable controlled displacement loading (Figure 2). The rig was configured to have the central 3.5m pipe section under constant bending moment. Although the rig was fitted with horizontal actuators able to exert up to 250 tonnes load at each end, to apply axial tension or compression loading during bending, the application of end loading during installation and service bend testing was excluded by the specification.

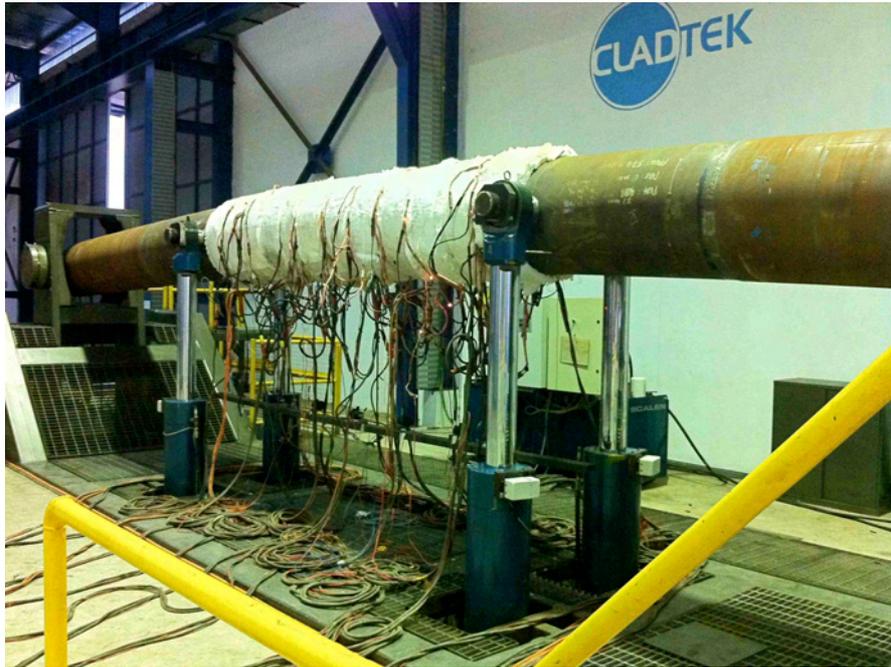
FIGURE 3: Photograph of Test Pipe on Test Rig with Heating and Instrumentation

Heating was achieved using electric ceramic pad heaters strapped to the external diameter and compressed air was used as the pressurising medium (with appropriate safeguards).

Instrumentation used to monitor the bend testing included: 12 strain gauges mounted on the external surfaces at 0° and at 180° positions to measure local axial strain; 5 displacement transducers to measure the deflection of the pipe and calculate global bending strain, 1 dial type pressure gauge, 1 electronic pressure transducer, 4 thermocouples and 2 networked HD digital video cameras with light sources. The cameras were fixed inside the pipe, one either end, to view the central 3.5m section during bending. On account of the low angle ‘back’ lighting effect, the cameras were able to detect very small liner deformations. The output from the instrumentation was captured by a data acquisition system and recorded digitally.

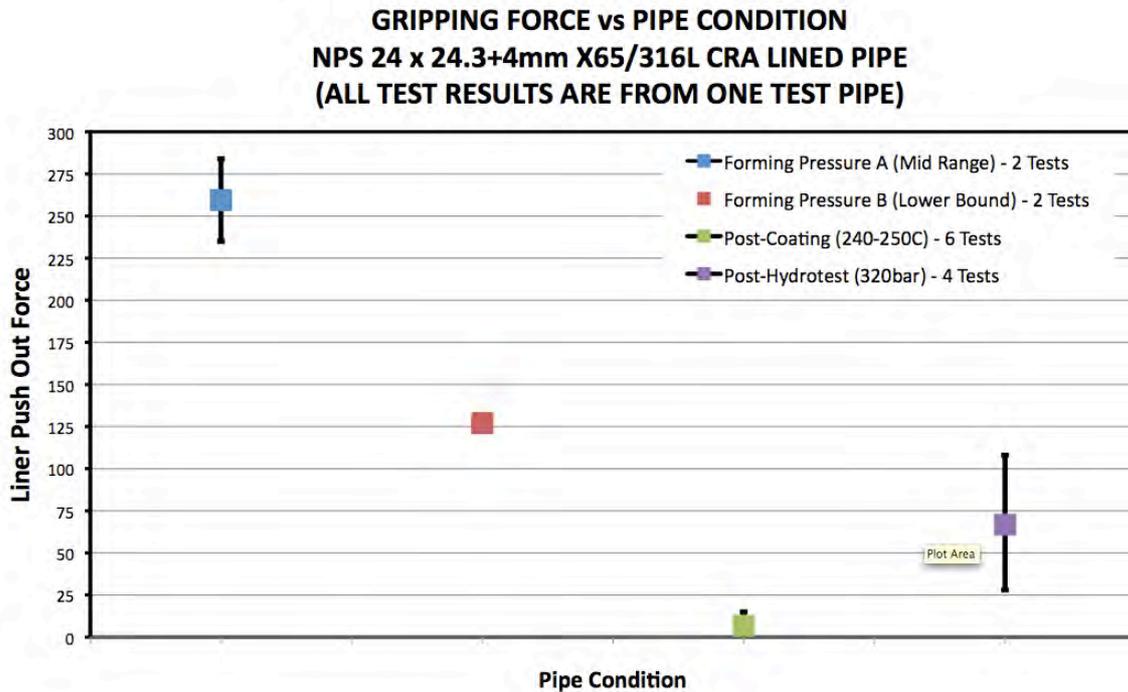
FIGURE 4 - Chart showing Variation of Gripping Force with Pipe Condition

The extent of the reduction is illustrated by Figure 4, which compares the ex-mill average gripping force for two different expansion pressures (lower bound and mid range) with the average gripping force measured after coating simulation. The average liner gripping force has dropped from 260kN to 7kN after coating simulation. This is a known effect due to the CRA liner having a larger coefficient of thermal expansion than the backing steel. The thermal expansion coefficient for 316L and CS are 16.5×10^{-6} mm/mm/°C and 13.0×10^{-6} mm/mm/°C respectively. Increasing the temperature increases the grip force until the point is reached when the CRA liner undergoes compressive yielding, at which point the grip force is reduced.

The temperature used during pipeline coating (240-250°C) is sufficient to cause compressive yielding of the liner with the result that the grip force is substantially reduced after coating.

Liner gripping force can be restored (at least partially) by performing a pressure test after pipeline coating. The pressure test has to cause the liner to yield and increase the liner contact pressure. However if the test pressure is lower than the original expansion lining pressure, the 'restored' level of grip will be lower than the original level of grip (Figure 4).

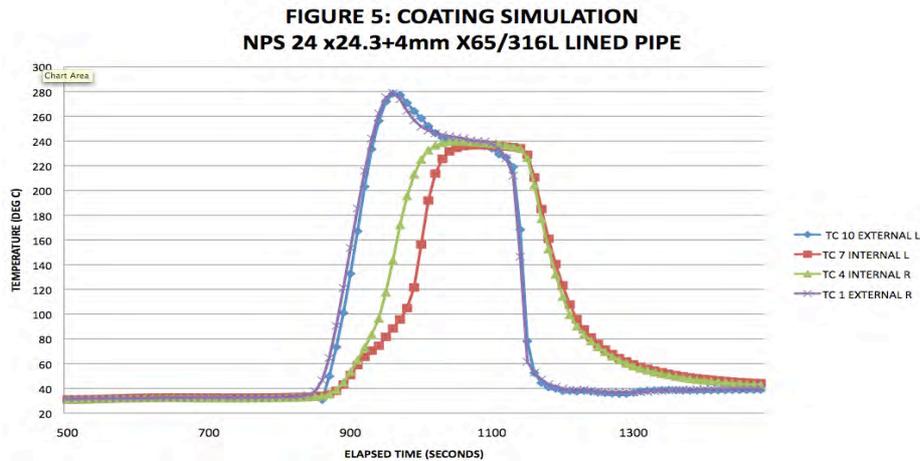
FIGURE 5 - Simulation of Coating Thermal Cycle (Temperature v Time)

Cladtek performed the coating simulation by feeding the NPS 24 lined pipe through an 800kW induction furnace with water quench. There was no data available from coaters for the internal temperature during coating so the induction furnace was conservatively configured to heat the inner CRA liner surface to 240-250°C. Figure 5 shows the time-temperature profile achieved, measured using thermocouples attached to internal CRA and external CS surfaces.

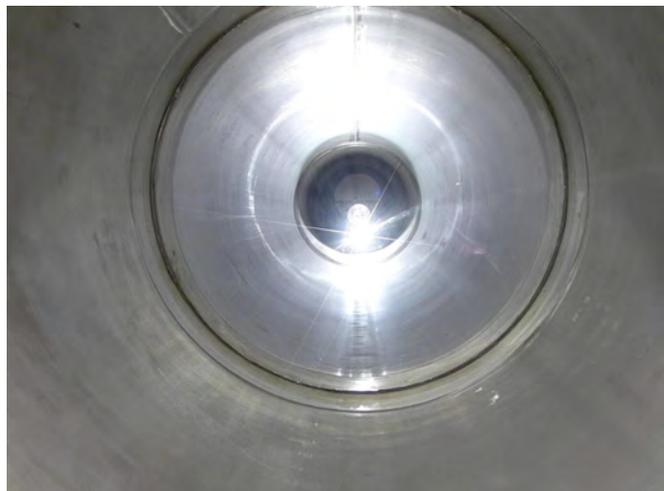
FIGURE 6 - NPS 24 Lined Pipe - No Wrinkles after +/-0.4% Strain (Ambient)

A few minor ripple-like features with height less than 1mm did appear at -0.4% strain in the area above the CS seam weld at the 180° position but they subsequently flattened and then disappeared when the axial bend loading was changed from compression to tension.

The test pipe was inspected on completion of the installation bend testing. No liner wrinkles or buckles were apparent in the pipe after completion of installation bend testing at +/-0.4%.

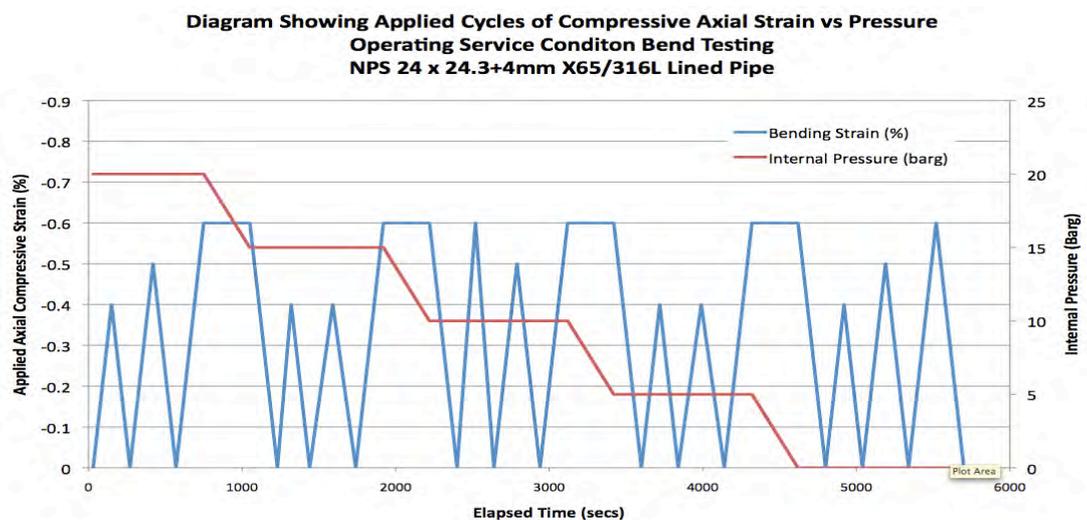
FIGURE 7: Operating Condition Bend Testing - Applied Strain vs Internal Pressure

- 1 cycle between 0% (straight) and -0.40% strain at 110°C and [0-20] barg
- 1 cycle between 0% (straight) and -0.50% strain at 110°C and [0-20] barg
- 1 cycle between 0% (straight) and -0.60% strain at 110°C and [0-20] barg

Figure 7 illustrates the cycles of strain and internal pressure in the order they were applied.

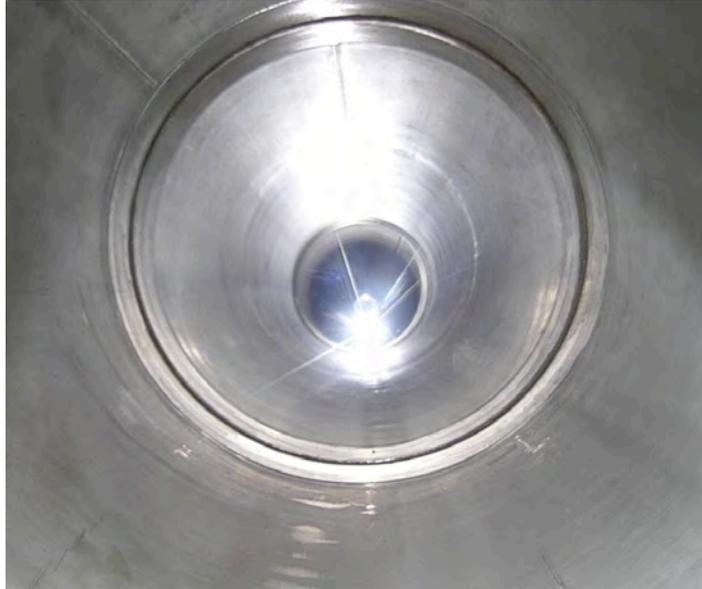
FIGURE 8: NPS 24 Lined Pipe - No wrinkles at -0.80% strain, 110°C and 20barg

One test pipe was re-pressurised to 20 barg and while still at 110°C, was strained to -0.73% and then -0.80%. Figure 8 is a still that shows this pipe without wrinkling when the axial compressive strain was -0.80%, temperature was 110°C and internal pressure was 20 barg.

As Figure 8 shows, there were no signs of any ripples or wrinkles in the liner at an axial compressive strain of -0.80% at 110°C with 20barg overpressure.

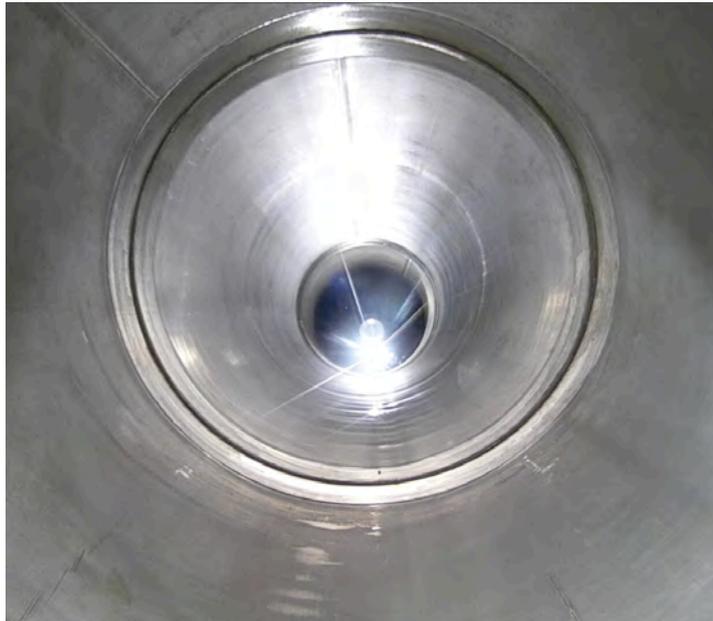
FIGURE 9: NPS 24 Lined Pipe - Wrinkles at -1.0% strain 110°C with ZERO overpressure

Liner wrinkling was clearly visible at -1.0% strain although the onset of wrinkling was judged to occur at about -0.83% strain with 0 barg pressure. Figure 9 is a still frame that shows wrinkling in the liner at an axial compressive strain of -1.0% at 110°C and 0 barg pressure.

After straining to -1.0%, the test pipe was removed and the wrinkles examined further. The wrinkle height was found to vary between 0.5mm and 1.0mm, with a separation or spacing of about 100mm between adjacent wrinkles. There were no indications of surface defects.

The liner wrinkling had initiated in the liner above the CS seam weld, which is consistent with expectations given that the CS seam weld presents a geometrical imperfection.
